# Natural Hazards Vulnerability of the Dominica Hydroelectric Expansion Project

This report documents the findings from the vulnerability to natural hazards audit of the hydroelectric expansion project. The audit included examining actions necessary to reduce vulnerability through both retrofitting and maintenance. This information will be used to establish related costs for reducing vulnerability.

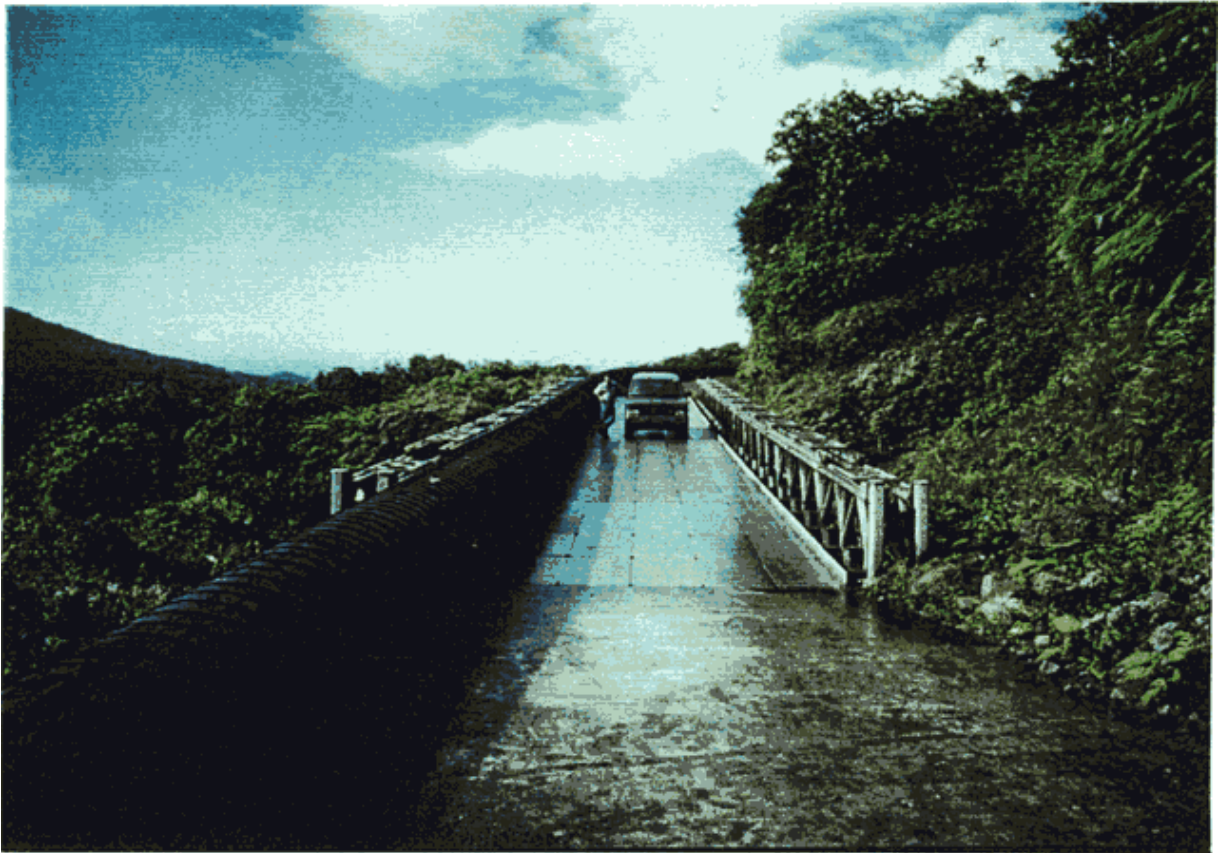
Landslides affected another part of the project in 1989. Excavation of the pipeline right-of-way between Fresh Water Lake and the surge tank above the Laudat power station was done between June 1989 and September 1989. However, a large landslide occurred at the end of August 1989 during a heavy storm (Fig. 11). This landslide from the slopes of Morne Macaque destroyed part of the pipeline pad. The subsequent passing of hurricane Hugo the following month and several other several storms in the succeeding months caused additional damage to the pad and destroyed the site access road (Fig. 12). A design change was required to complete the pipeline along its original alignment. This was accomplished by erecting a modular bridge across the slide path to support the pipeline and restore vehicular access to Fresh Water Lake. Completion of the pipeline was delayed until October 6, 1990 due to the time required to purchase materials and

Figure 3. Low pressure woodstave pipeline from Fresh Water Lake to the Laudat surge tank. This section was re-designed to incorporate a Bailey bridge to restore the foundation pad destroyed by the Morne Macaque landslide in 1989.

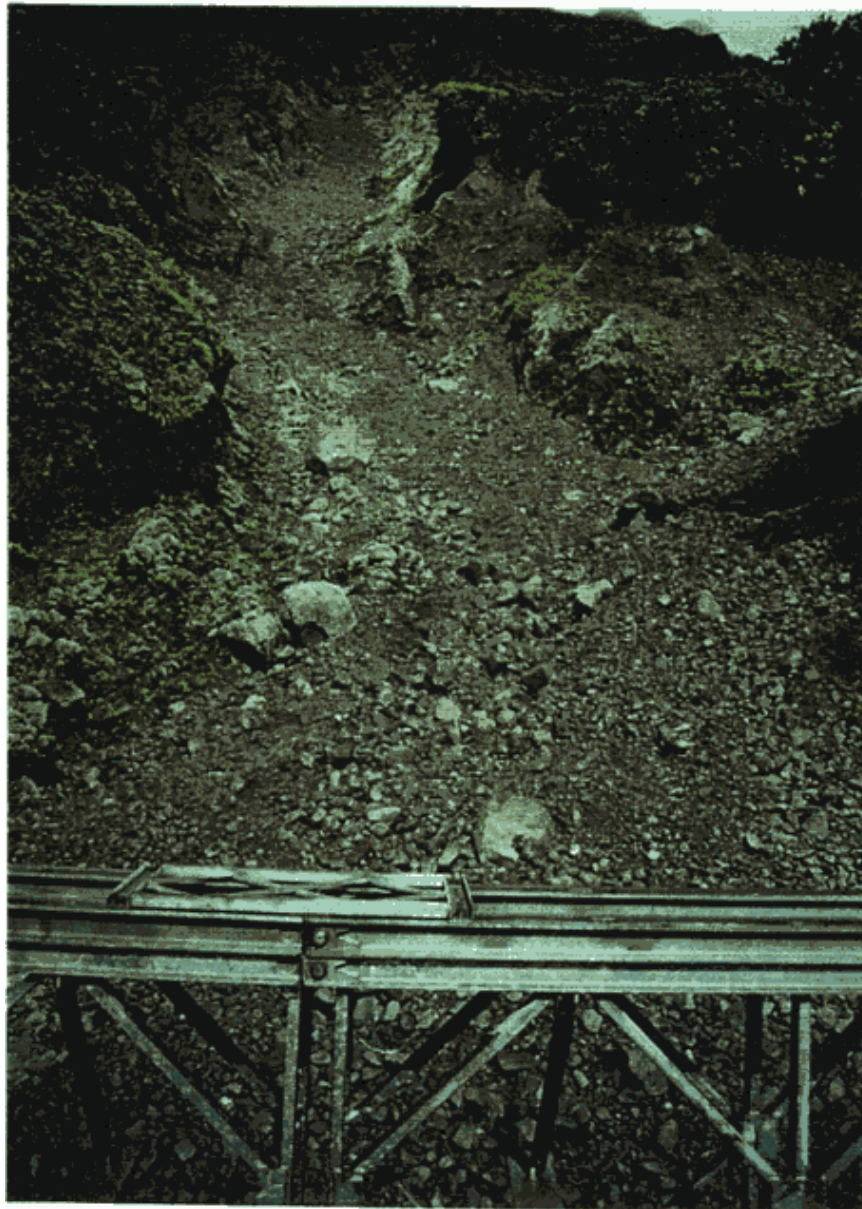
Figure 11. View upslope of the large landslide on the slopes of Morne Macaque which ocured in 1989. The view is taken from the Bailey bridge installed to convey the woodstave pipeline from Fresh Water Lake across the slide-created gorge. The upper part of the landslide is between 2,500 adn 3,000 feet upslope from this view point.

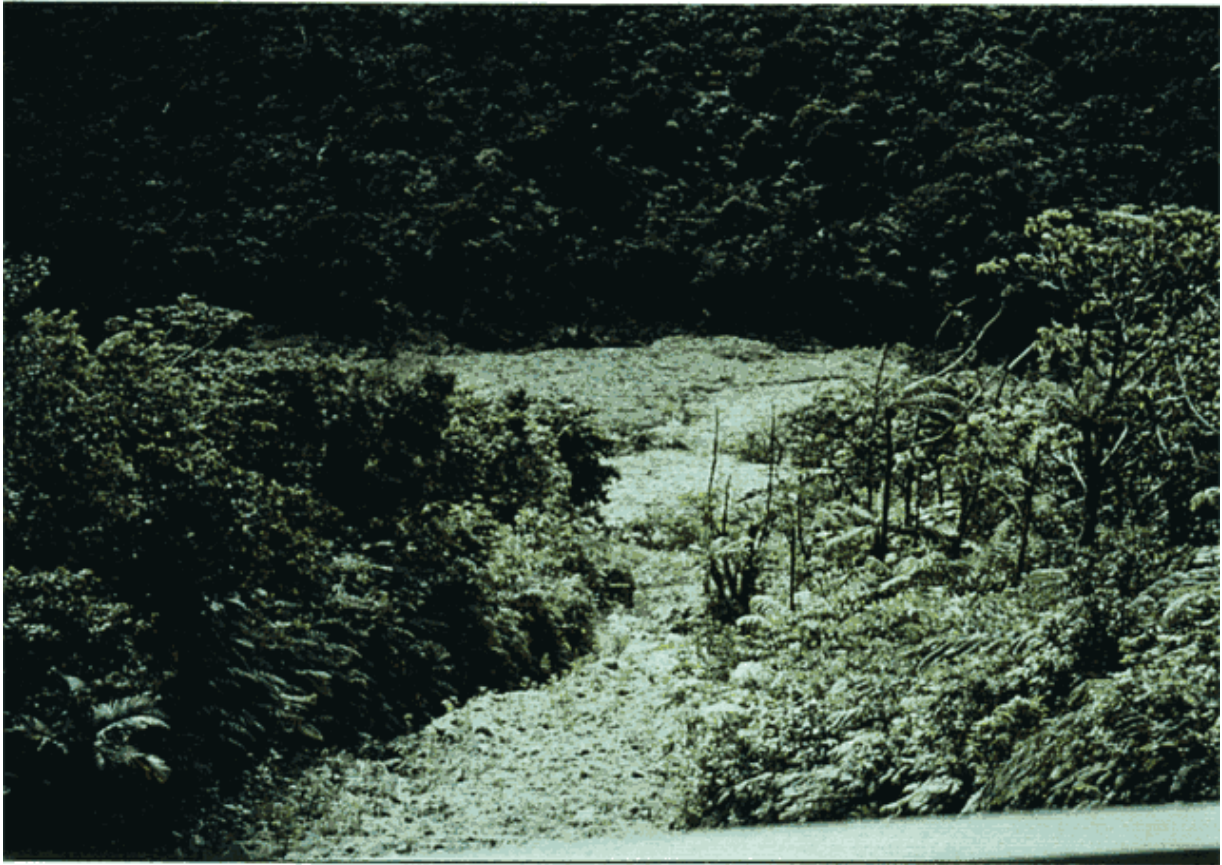
Figure 12. View downslope from the Bailey bridge showing the path of the large landslide downslope and the landslide deposit of rock and soil in the Roseau River valley bottom. The deposit is located upstream of Titot Gorge and generated sediments affecting the Titot Gorge intake.

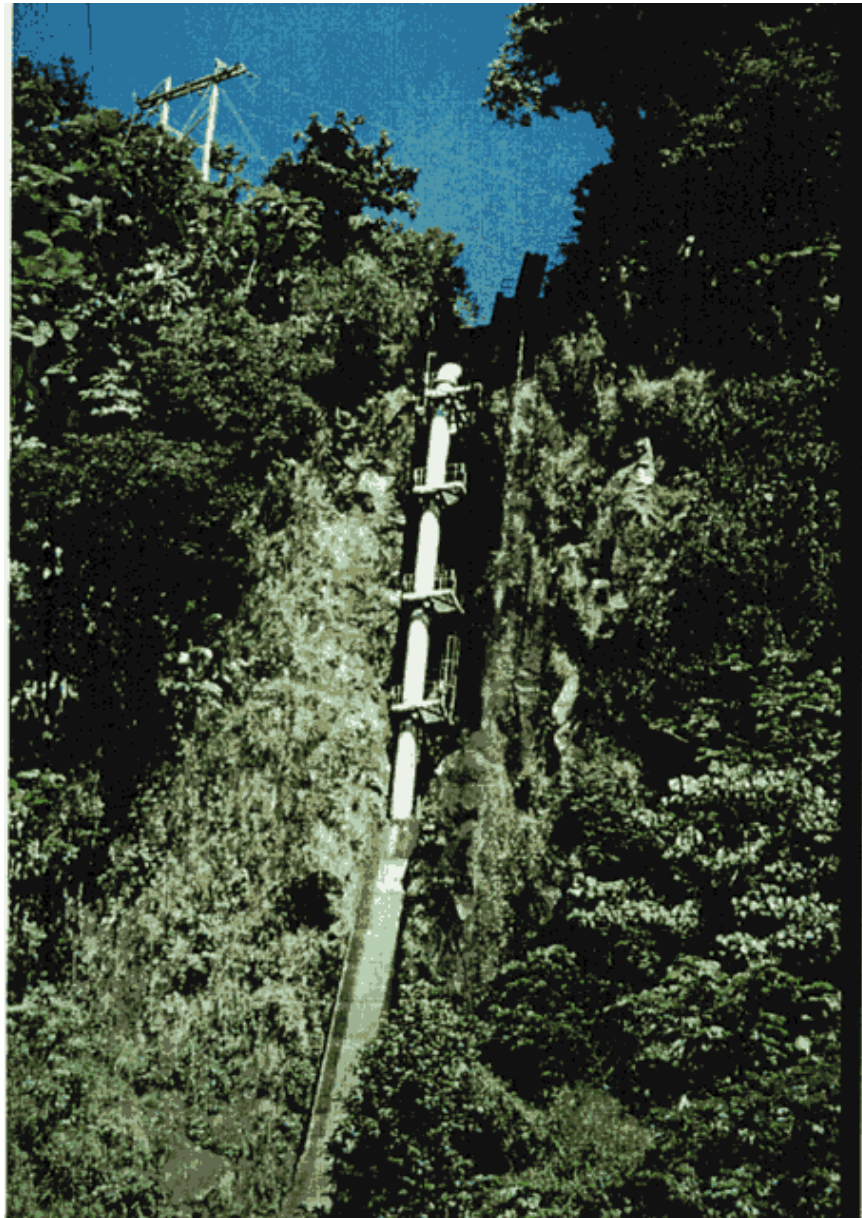
Natural slope instability also caused a design change in 1990 (Anonymous, undated). The Contractor responsible for installing the pipeline down the face of Trafalgar cliff employed a subcontractor with experience in acrobatic services to install an overhead cableway for dismantling the existing pipe and completing construction of the new pipeline. In April, rock movement was suspected during excavation of the recess in the cliff face for the new pipeline. This necessitated removal of a rock overhang and installation of an anchoring program. Completion of the anchoring program was delayed by lack of materials and breakdown of equipment. When work on the excavation resumed in September 1990, but stopped later the same month when a section of rock along the recess slipped. This resulted in installation of another anchoring program and a design change in the lower portion of the pipeline support from platforms to a concrete encasement (Fig. 13). The cost to the project for the change in design to support the pipeline is estimated to be \$563,000 EC.

Figure 13. Closer view of Trafalgar Cliff showing the steel support and concrete encasement design necessitated by rockfall instability. The bedrock at this location is recognized in landslide hazard mapping (DeGraff, 1987) as associated with rockfalls and rockslides in nearby river valleys.

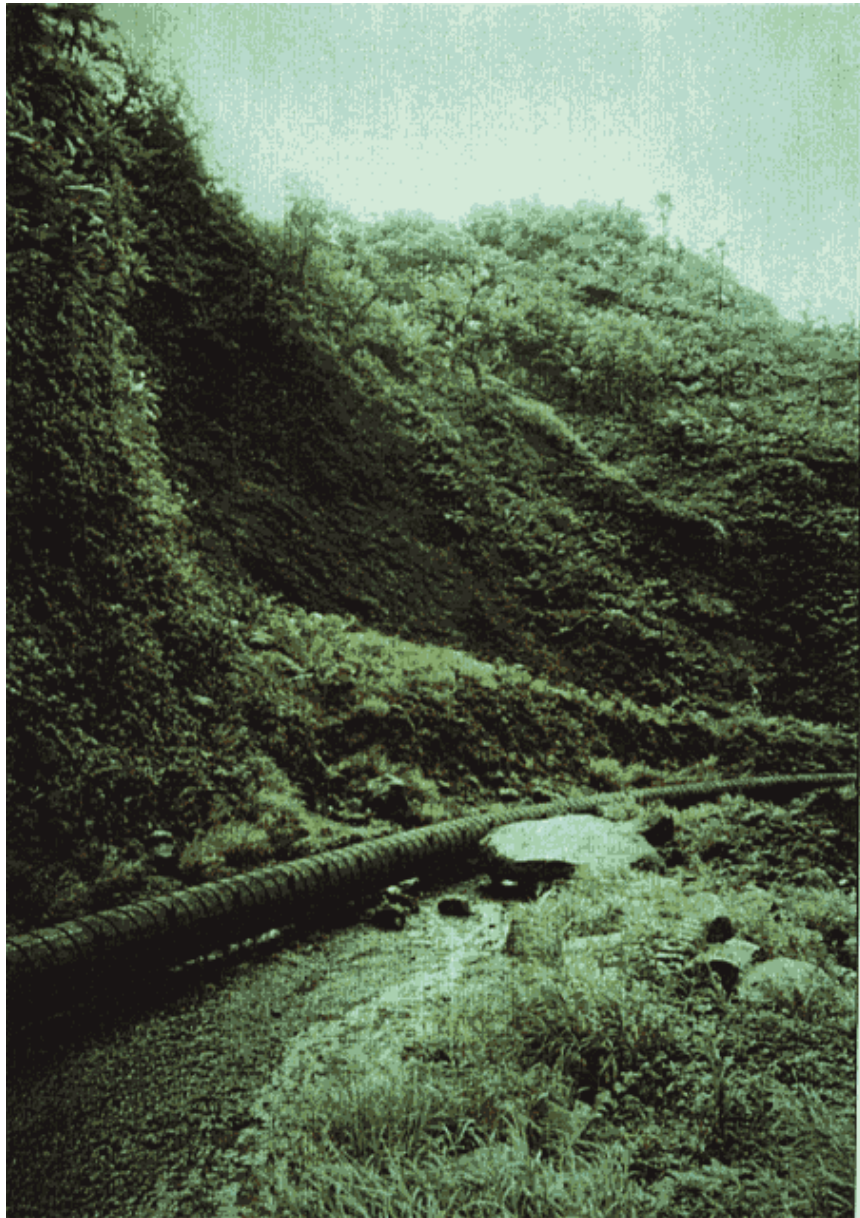
Location of the pipelines in high hazard areas without adequate consideration of this hazard in the design also has caused higher operational costs for the DOMI&C (Mr. F.~ Hamlet, 1994, Pers. Comm.). In May 1992, two landslides occurred along the Clarke's river diversion pipeline. Both landslides broke the pipeline and caused temporary loss of water to the Fresh Water Lake. One slide occurred near the Clarke's river diversion. It displaced the pipeline and partially buried it (Fig. 14). It took about 3 weeks for hand crews to remove the debris and repair the pipeline. The site was inaccessible to equipment to assist in this task. The second landslide occurred along the pipeline just south of the throughput area. This slide displaced the pipeline laterally to cause the break. This material was also removed by hand crew during pipeline repair. Both failures were in soil with movement occurring at a shallow depth estimated to be within 1 to 4 meters. The landslide near the diversion structure included several large boulders with diameters of 0.5 to 1.5 meters. The restoration of the pipeline to service after the May 1992 landslides was estimated to be \$70,000 EC.

Figure 14. View of the landslide which damaged the woodstave pipeline near the Clarke's river diversion. The diversion structure is just beyond and to the right of this view. Slide material ranged from soil particles to the boulders such as the one visible in the foreground.

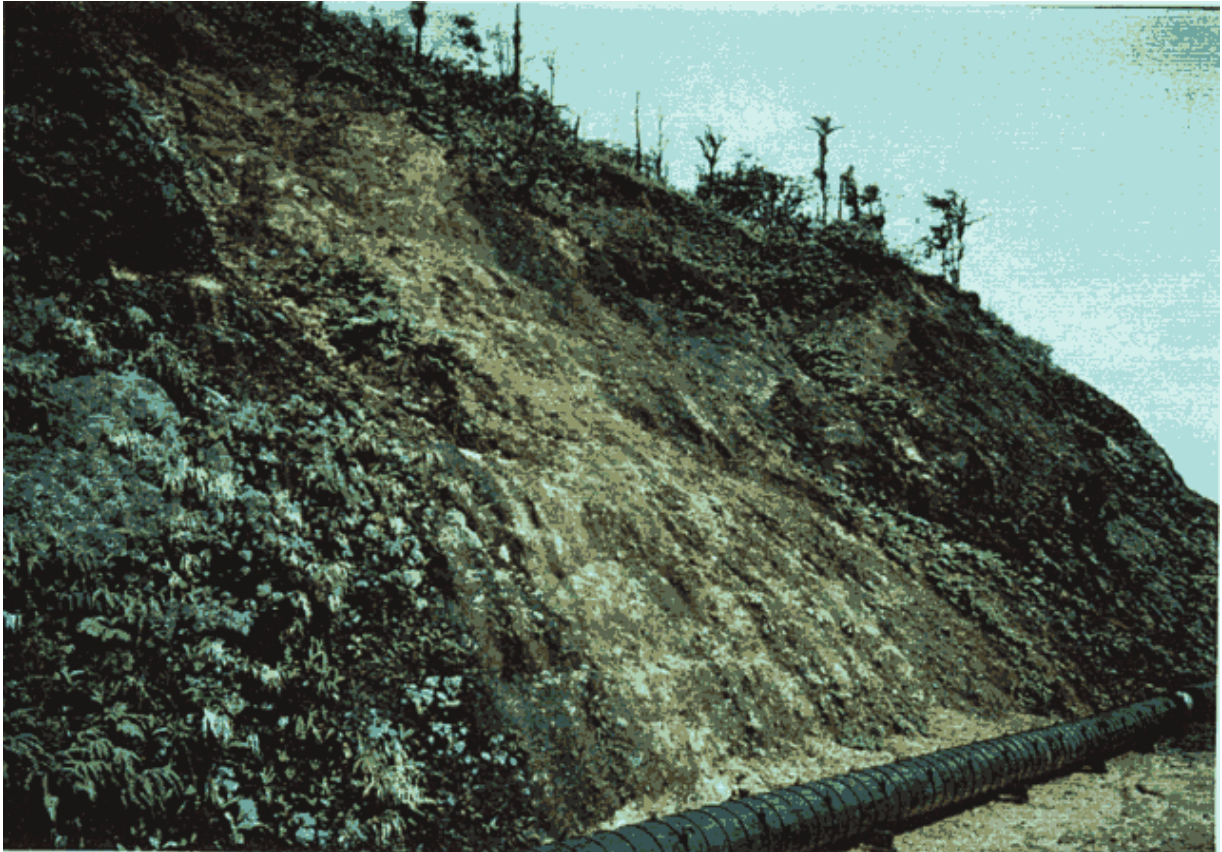
In April 1993, two more landslide impacted water delivered to and from Fresh Water Lake. One landslide occurred at nearly the same location on the Clarke's river pipeline south of the throughput as the one in May 1992 (Figs. 15 and 16). The other landslide occurred on the pipeline from Fresh Water Lake to Laudat power station. It was located just below the dam at Fresh Water Lake. Repair to these pipeline breaks required the same type of work as done the previous year. The cost is estimated to be about \$30,000 EC. Neither repair cost includes lost revenue related to power generation.

Figure 15. View of the section of the woodstave pipeline from Clarke's river diversion which was affeted by landslides in 1992 and 1993. A repaired break in the pipeline is seen at the far end.

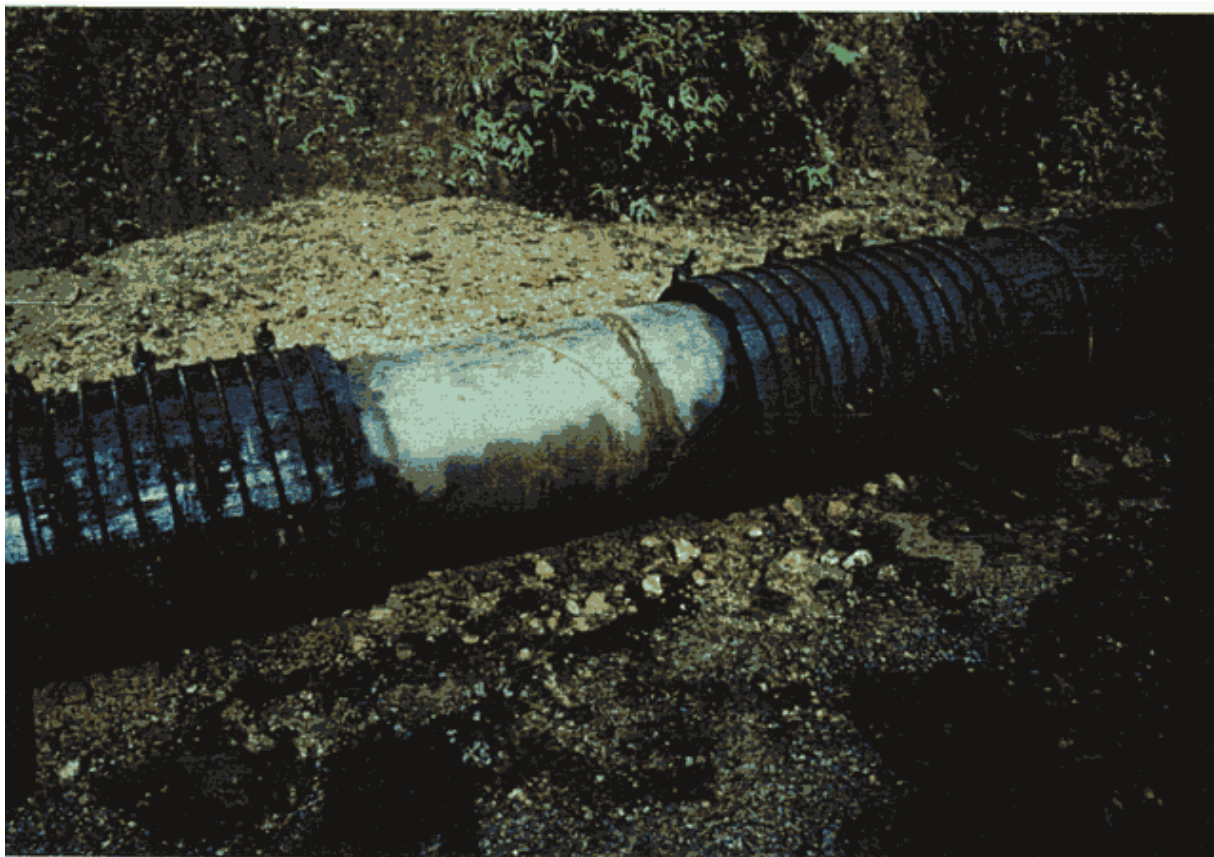
Figure 16. A close up view of the repaired break in the Clarke's river diversion woodstave pipeline. This is the section visible in Figure 15.
